NUREG/CR-5779  
ORNL-6687  
Vol. 1

# Aging of Non-Power-Cycle Heat Exchangers Used in Nuclear Power Plants

Operating Experience and Failure Identification

Prepared by  
J. C. Moyers

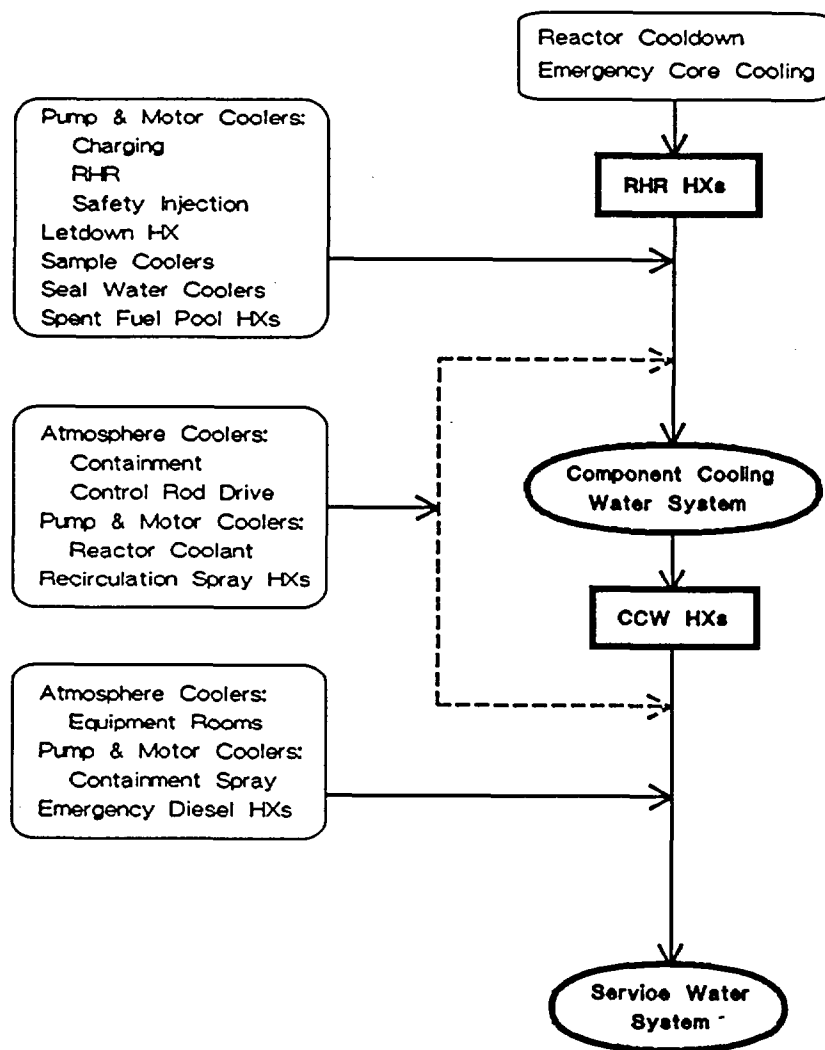
Figure 2.1 Thermal management in PWR plants

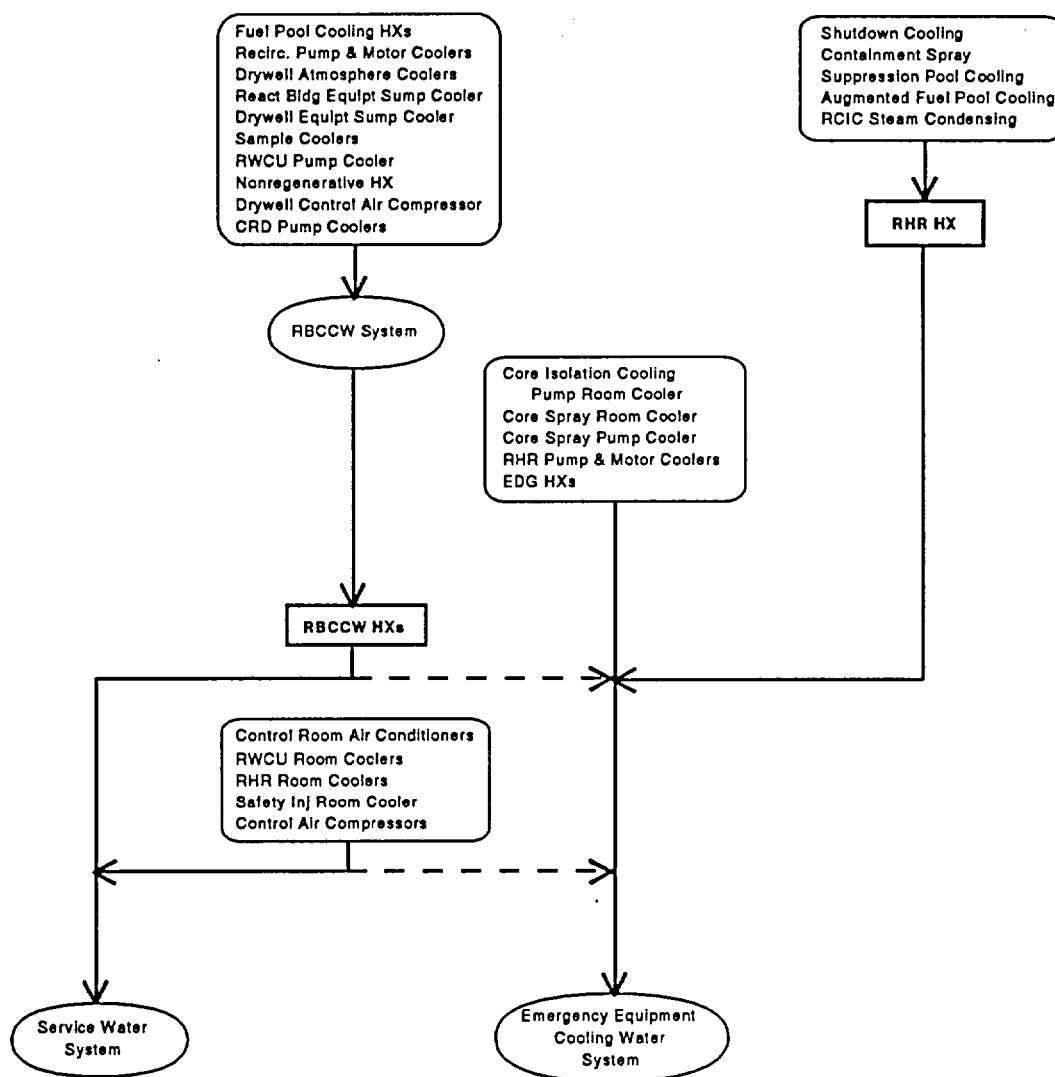
Figure 2.2 Thermal management in BWR plants

Typical thermal management in boiling water reactor (BWR) plants is represented schematically in Fig. 2.2. The functions served by the complement of heat exchangers in BWR plants are similar to those in PWR plants as discussed in the preceding section, and the designs are similar, also. Those functions that are served by the Component Cooling Water System in PWRs generally are fulfilled by the Reactor Building Closed Cooling Water System in BWRs. Upon loss of offsite power, critical cooling loads are shifted from the Service Water System to the Emergency Equipment Cooling Water System, as indicated by the dashed lines in the figure.

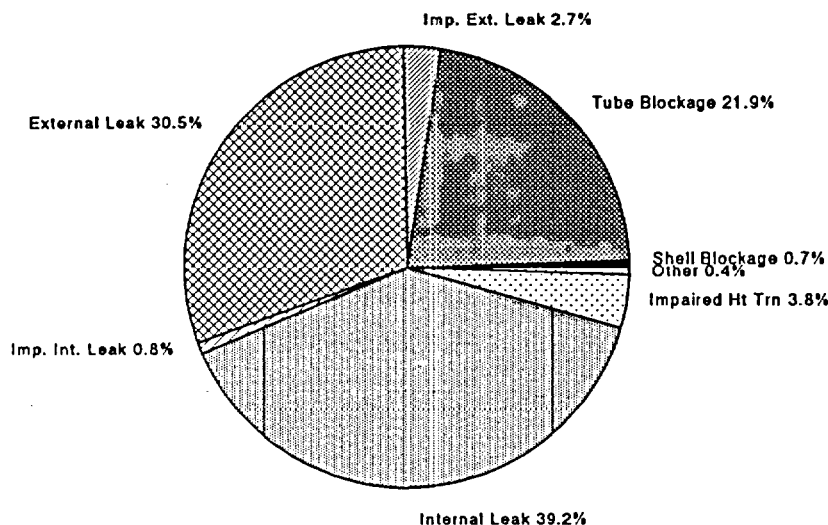
Figure 5.1 Distribution of events by failure type, all functions

The distribution of reported events by failure type for all heat exchanger functions is shown in Fig. 5.1. Three failure types account for more than 90% of the total number of reported events. Internal leaks, between the two fluid streams, is the leading failure type at 39% of the total. External leaks is the second-most prevalent failure type, at 30% of the total, and tube blockage is third, at 22% of the total. Minor internal or external leakage often does not compromise the safety function of a heat exchanger, but may result in low-magnitude environmental releases. Tube blockage is a safety-threatening event, involving not only the affected exchanger but indicating the potential for a common-mode failure of other exchangers receiving flow from the same source. Impaired heat transfer events, in which the heat transfer surface becomes fouled to the extent that the exchanger cannot accomplish its intended function, account for less than 4% of the total. This paucity of reported events may be due to limited application of performance testing programs needed to detect the degradation of heat transfer capabilities.

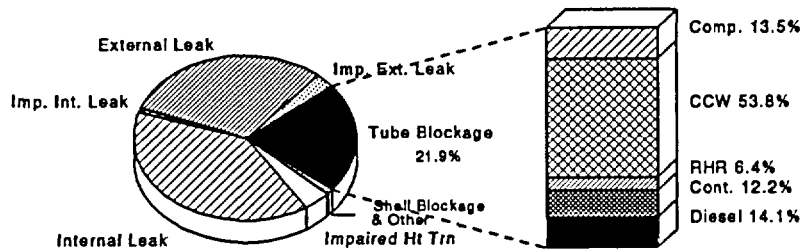
Figure 5.2 Distribution of tube blockage by heat exchanger function

The distribution of the 156 reported tube-side blockage events among the various heat exchanger functions is shown in Fig. 5.2. More than half the events occurred in the Component Cooling Water

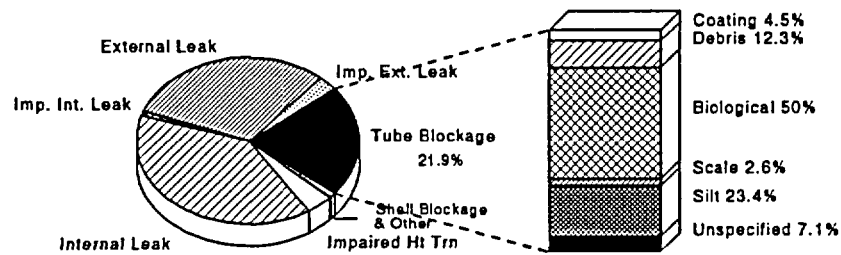
Figure 5.3 Distribution of tube blockage by cause

The distribution of blockage events by reported cause is shown in Fig. 5.3. Half the events are attributed to biological causes, either biological growth that occurs in place or debris from bivalves. Blockage by silt (23%) and debris (12%) account for most of the remaining identified event causes.

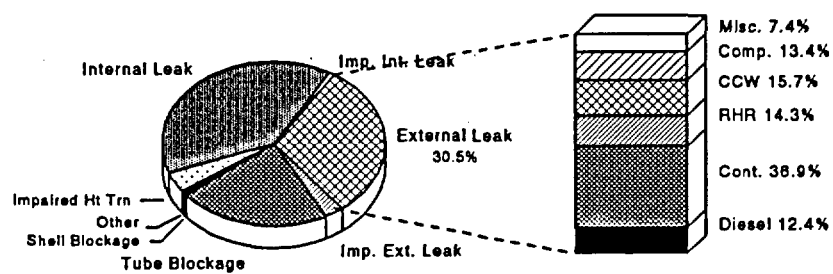
Figure 5.4 Distribution of external leakage by heat exchanger function

The distribution of external leakage events by heat exchanger function is shown in Fig. 5.4. More than

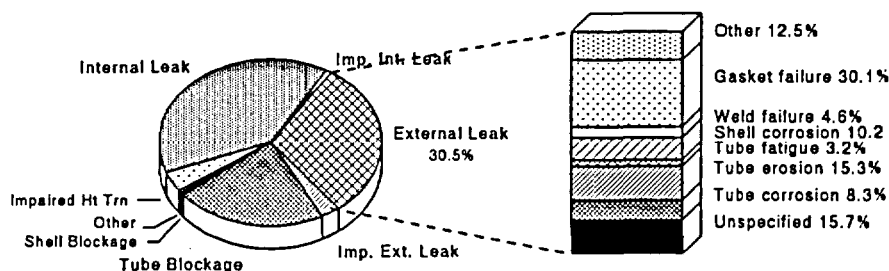
Figure 5.5 Distribution of external leakage by cause

Distribution of the events by cause is shown in Fig. 5.5. Gasket and weld failures and shell corrosion, all in shell-and-tube exchangers, account for about 45% of the total. Almost all of the cause-unspecified failures represent tube failures in containment atmosphere coolers; these and other tube failures attributed to erosion, corrosion, and fatigue occurred in air coolers, either containment atmosphere or motor coolers. Erosion due to excessive water velocity or entrained silt was the most-often cited cause of tube failures. The 'Other' cause category includes a wide variety of miscellaneous occurrences, such as loose flange bolts, faulty fittings and plugs, and manufacturing or design deficiencies.

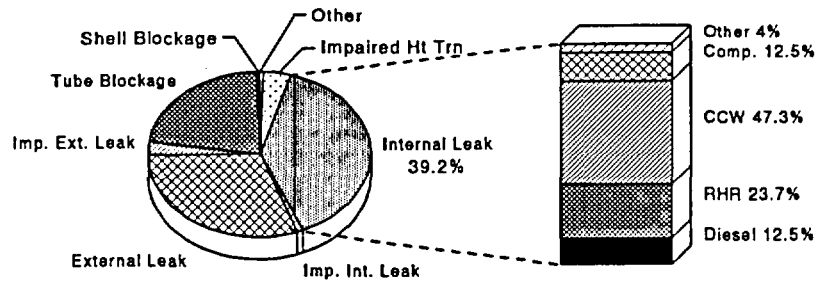
Figure 5.6 Distribution of internal leaks by heat exchanger function

The distribution of the inter-fluid, or internal, leakage events by heat exchanger function is shown in Fig. 5.6. Almost half the reported events were in component cooling water heat exchangers and almost one-quarter were in RHR exchangers. Review of the data revealed that 94% of the internal leakage events for RHR exchangers occurred in BWR plants, resulting to some extent from the practice of using service water to cool these exchangers in those plants. Heat exchangers for cooling components and for diesel cooling each accounted for one-eighth of the total.

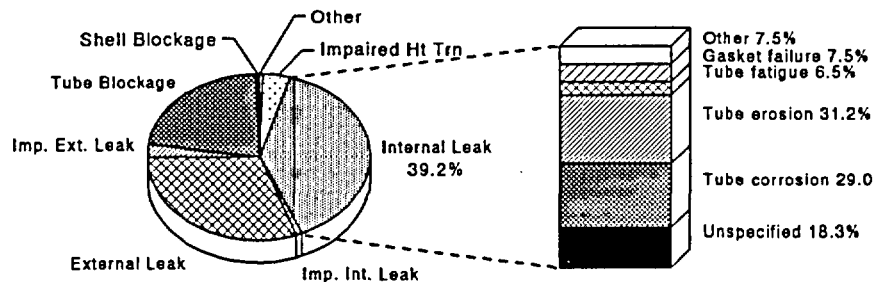
Figure 5.7 Distribution of internal leaks by cause

Distribution of the events by attributed cause is shown in Fig. 5.7. Two-thirds of the events were from tube leaks attributed to corrosion, erosion, and fatigue. In addition, many of the cause-unspecified events were tube leaks. Corrosion was the major cause of tube failures in RHR exchangers and 84% of these corrosion-caused failures occurred in BWR plants, probably reflecting the effect of long periods of idleness (during normal reactor operation) with

incomplete replacement of contained service water by demineralized water for the idle periods. In CCW exchangers, erosion was the leading attributed tube failure cause (49% versus 42% due to corrosion), reflecting continuous flow of service water in these exchangers. Most of the inter-fluid leaks attributed to gasket failures were in RHR heat exchangers, occurring in floating head joints.

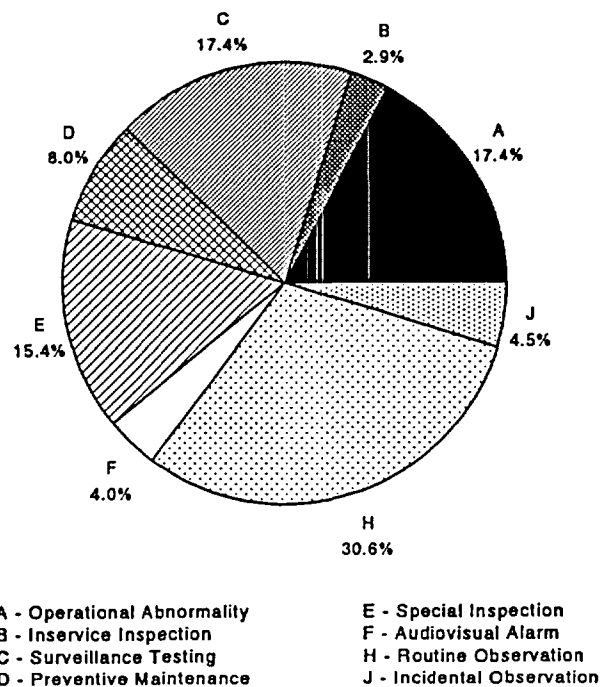
Figure 5.8 Detection methods, all failure types

The distribution of all failure types by detection category is shown in Fig. 5.8. Detection by routine observation during normal activities of plant personnel was the leading means for failure recognition, accounting for almost one-third of the total. Detection from operational abnormalities, surveillance testing, and special inspections each account for near-equal fractions of the total and, in combination, accounted for half the total. Detection during preventive maintenance activities accounted for eight per cent of the total, and less than five per cent each were detected by incidental observation, audiovisual alarms, or inservice inspection.

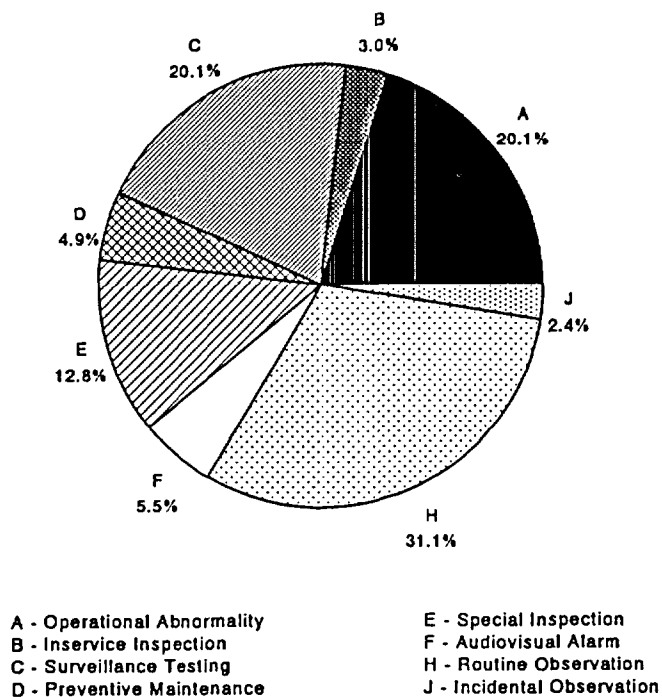
Figure 5.9 Detection methods, tube blockage

Flow blockage failures were most often recognized by excessive pressure differential (approximately 53% of events). Other blockages were found during inspections and tests (21%), by high system or component temperatures (14%), or by low flow (12%). The distribution, by method of detection, of tube blockage failures as shown in Fig. 5.9 is quite similar to that for total failures. Routine observations account for about one-third of the total, followed by operational abnormalities and surveillance testing at one-fifth each. Special inspections detected about one-eighth of the tube blockage failures, and the remainder were detected by audiovisual alarms, preventive maintenance, inservice inspection, and incidental observation.

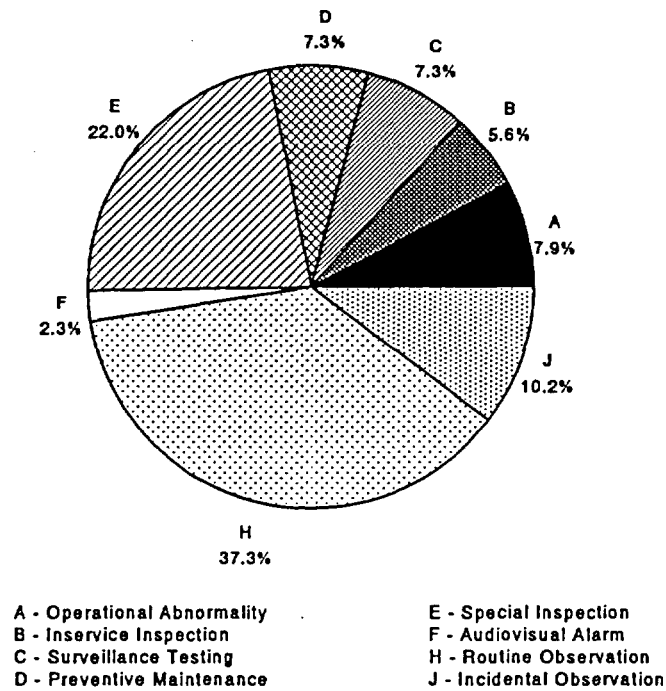
Figure 5.10 Detection methods, external leakage

Detection of external leakage failures was distributed among detection methods as shown in Fig. 5.10. This type of failure often has visible effects and is more readily observable than other failure types. As with tube blockage failures, the dominant detection method was routine observation, comprising 37 per cent of the total. Special inspections detected more than one-fifth, and incidental observation one-tenth of the total.

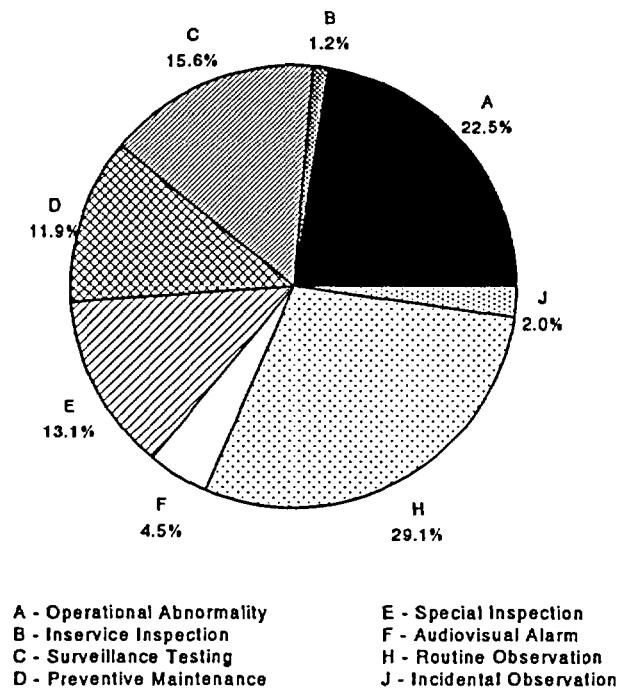
Figure 5.11 Detection methods, internal leakage

inspections and tests, or from visual observation (such as water in lubricating oil). Distribution, by detection method, of the internal leak failures is shown in Fig. 5.11. Slightly more than half the failures were detected by routine observations and operational abnormalities. Surveillance testing, special inspections, and observations during preventative maintenance each accounted for about one-eighth of the total.

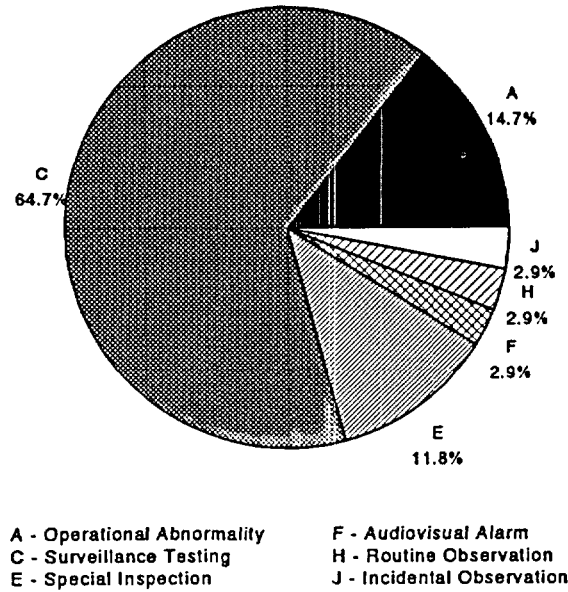
Figure 5.12 Detection methods, impaired heat transfer

Failures due to impaired heat transfer were detected as shown in Fig. 5.12. Almost two-thirds were detected during surveillance testing. Operational abnormalities, often consisting of excessive system or component temperatures, revealed almost 15 per cent of the failures and special inspections, often resulting from observance of operational abnormalities, accounted for almost 12 per cent of the total.
